Help with Common Lab Problems

3M ESPE Impression Tips

BECAUSE FIRST IMPRESSIONS COUNT

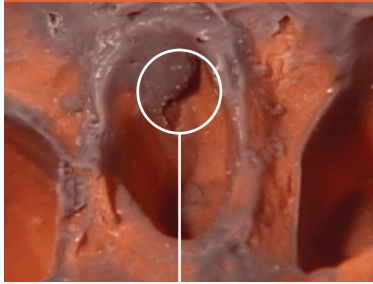
Photo #1 Ledges

Issue	Cause	Solution
<ul style="list-style-type: none"> ■ Ledges. (photo #1) 	<ul style="list-style-type: none"> ■ ■ Rapid tray seating. 	<ul style="list-style-type: none"> ■ ■ Position the tray before seating. Use a slow, steady, vertical seating motion to allow for blending of tray/wash materials.
<ul style="list-style-type: none"> ■ Drags. (photo #2) 	<ul style="list-style-type: none"> ■ Placing and seating the tray in the mouth in one motion. 	<ul style="list-style-type: none"> ■ Carefully position the tray before seating. Once positioned, seat the tray vertically.
<ul style="list-style-type: none"> ■ Delamination (poor blending and adhesion of wash to tray material). 	<ul style="list-style-type: none"> ■ Failure of the impression material to adapt to the teeth. 	<ul style="list-style-type: none"> ■ Seat the tray slowly.
<ul style="list-style-type: none"> ■ Slanted or wavy teeth. 	<ul style="list-style-type: none"> ■ ■ Teeth rebounding off the tray and sliding into position. 	<ul style="list-style-type: none"> ■ Avoid contact of teeth with tray.

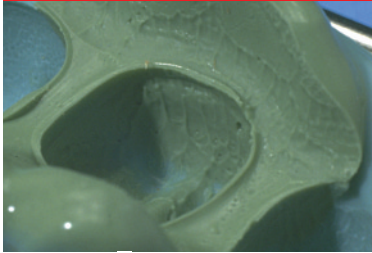
**Photo #1 Surface Inhibition-
Simultaneous Medium/
Light Technique**

- The surface of the impression material is not set, tacky to the touch, and visually resembles the surface of an orange peel (Photo #1).
- Unset impression material residue may be transferred from the impression to the die stone during model pouring (Photo #2).
- Wash slow setting.

- ■ Latex glove/rubber dam inhibition. Touching the prepared teeth or surrounding tissues, rolling retraction cord in gloved fingers, or the use of a rubber dam may transfer sulfur to critical areas of the impression; causing site specific inhibition.
- ■ Exposure to residues from custom temporary materials.
- ■ Exposure to air inhibited methacrylates (i.e., composites, adhesives, core build-up materials).
- Cartridge plugging.
- Product beyond its expiration date.
- Cause unknown.

- Wear vinyl gloves, or latex gloves which are proven not to inhibit the set of VPS impression materials. If contamination is suspected, scrub affected area with dilute hydrogen peroxide immediately prior to making the final impression.
- ■ Fabricate the temporary crown or bridge after the final impression has been made.
- ■ Remove air inhibited layer on the exposed surface with an alcohol wipe before making the final impression.
- If a plug is present, remove with an explorer. Bleed cartridge and attach a new mix tip.
- Purchase refill.
- Replace via 3M ESPE Technical Hotline (1-800-634-2249).

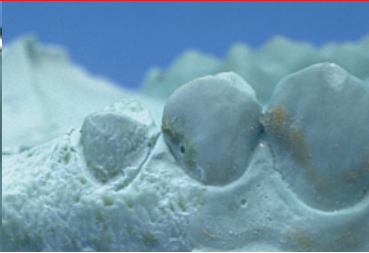
**Photo #2 Die Stone
with Impression
Material Residue**

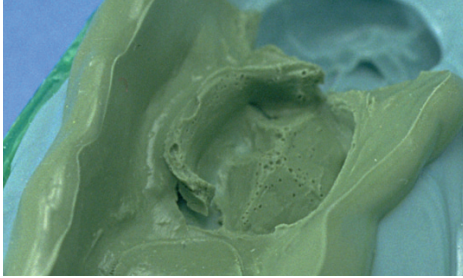
Tearing/Rough Surfaces

- Rough occlusal and/or incisal surfaces and tearing visible on the margin of the preparation (Photo).
- Poor lamination between tray material and wash may also be evident.

- Poor retraction technique.
- ■ Surface inhibition.
- ■ Moisture present.
- ■ Material slow setting (reason unknown).
- ■ Wash partially set at tray seating.
- ■ Early mouth removal.

- Improve retraction, and where appropriate, consider the two cord retraction technique.
- ■ Control bleeding and avoid pools of water or saliva on occlusal surfaces.
- ■ Replace via 3M ESPE Technical Hotline (1-800-634-2249).
- ■ Closely follow recommendations for oral work time.
- ■ Set a timer to ensure that the impression remains in the mouth for the full recommended set time.

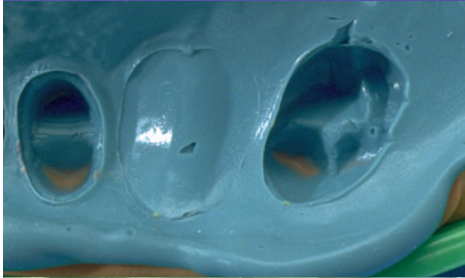
- Voids on the margin of a preparation compromise the fit and function of the final restoration (Photo).
- Voids on occlusal surfaces make articulation of stone models difficult.

- Syringe technique.
- Air incorporated when loading intraoral syringe.
- Moisture present either in the sulcus, or pooled on occlusal surfaces.

- Voids may be reduced by using a stirring motion while syringing, keeping the syringe tip immersed to avoid trapping air.
- Front load syringe by inserting mix tip directly into intraoral syringe and forcing the plunger backwards.
- Control bleeding, and when appropriate, consider the two cord retraction technique and/or hemostatic agents. Pools of water or saliva on occlusal surfaces should be avoided.

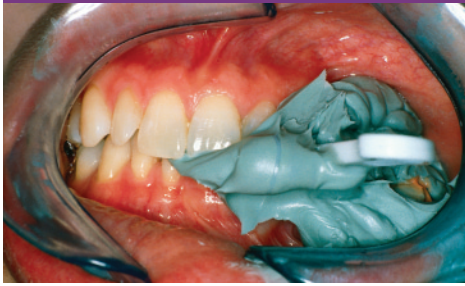
Double Bite Technique

- Short crown margins.
- Occlusal adjustment too high.
- Crowns too tight or too small.

- Teeth in contact with tray.
- Poor tissue retraction and/or moisture control.
- Early removal from mouth.
- Patient not in centric occlusion.
- Lack of tray support/weak tray/no walls.
- Early removal from mouth.

- Avoid contact of teeth with tray.
- Use double cord retraction technique.
- Follow recommended oral setting time.
- Try-in tray prior to making the impression.
- Establish repeatable orientation of the teeth.
- Identify contact areas or distinguishing features.
- Ensure that the crossbar does not interfere with achieving complete occlusion.
- Use rigid impression tray with walls.
- Follow recommended oral setting time.
